OHIO RIVER BASIN  
SHENANGO RIVER, CRAWFORD COUNTY  
PENNSYLVANIA

NDI No. Pa. - 176  
PYMATUNING RESERVOIR

PHASE I INSPECTION REPORT  
NATIONAL DAM INSPECTION PROGRAM,

11 AUGUST 1978

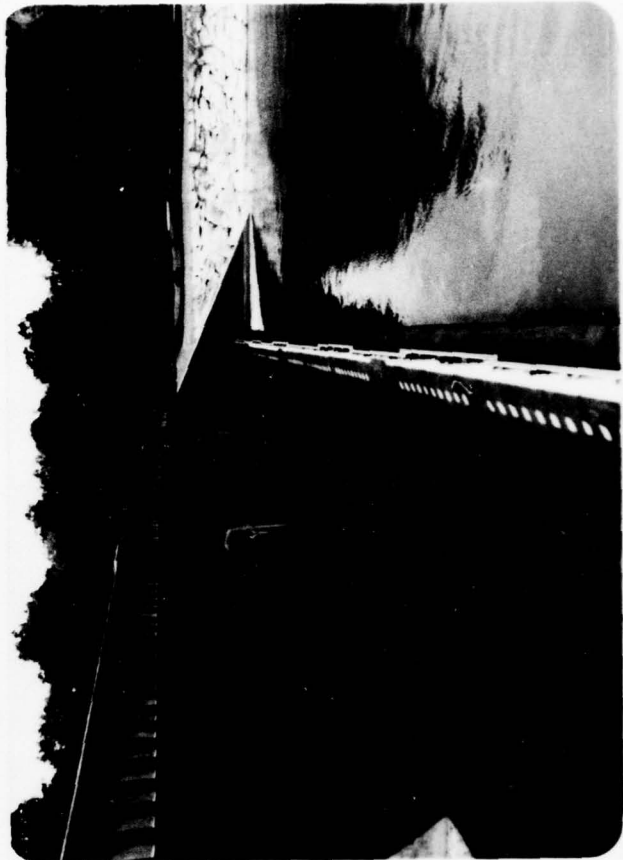
6

Another area of seepage was noted to the right (west) of the discharge end of the primary outlet structure (see Photographs 5 and 6). The seepage is passing through in-place soil and is partially diverted via two clay pipe drains which discharge onto the concrete walkway below. Total flow was minimal (could not be measured) and the condition is not considered serious under present conditions.

Two areas of seepage were found associated with the embankment. The first was noted to the right of the discharge end of the primary outlet structure (see Photographs 5 and 6). Seepage in this area was minimal and may be associated with tile drains which apparently drain the parking area atop the dam (see Figure 2).

Reportedly the spillway has never discharged. Some time after construction, 2 feet high flashboards were added to the ogee section in order to secure additional flood storage capacity (see Photographs 8 and 9). Section 17 of the Maintenance and Operations Manual for the facility states that the flashboards are so constructed that they will fail when they are overtopped by several feet of water.

View of the flashboards and ogee-crested spillway located in the right abutment.

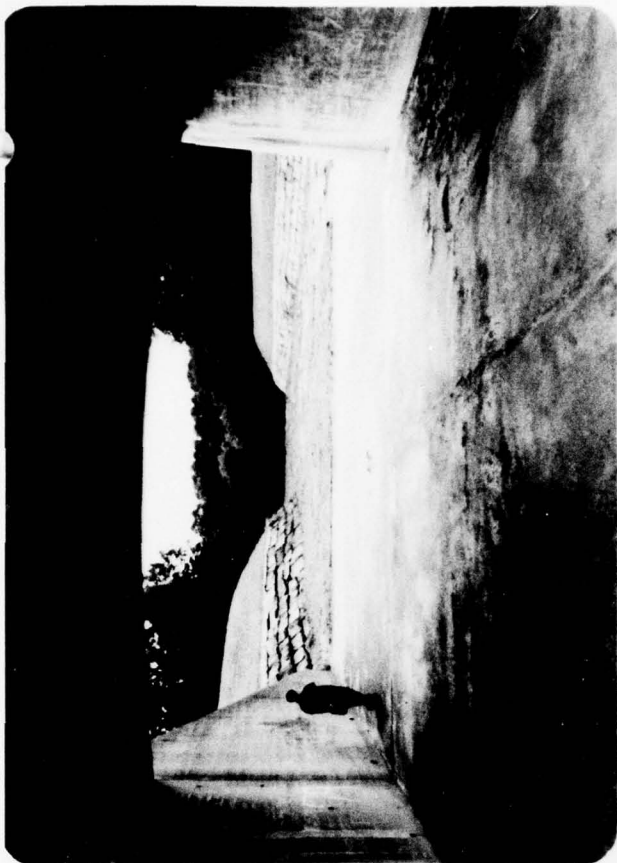
PHOTOGRAPH 10 View of the spillway channel just downstream of the ogee-crested weir.

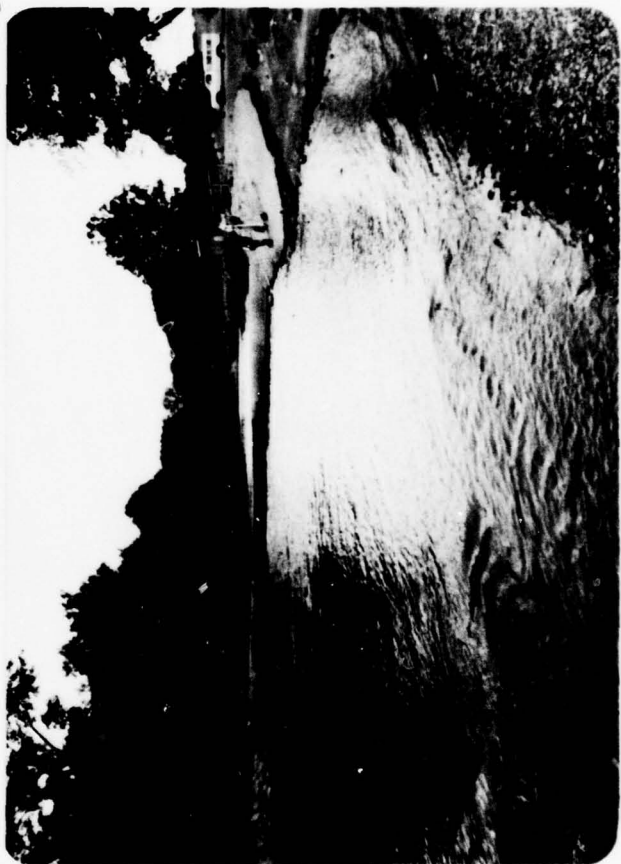
PHOTOGRAPH 11 View of the concrete weir located about 500 feet downstream of the Pymatuning spillway plunge pool.

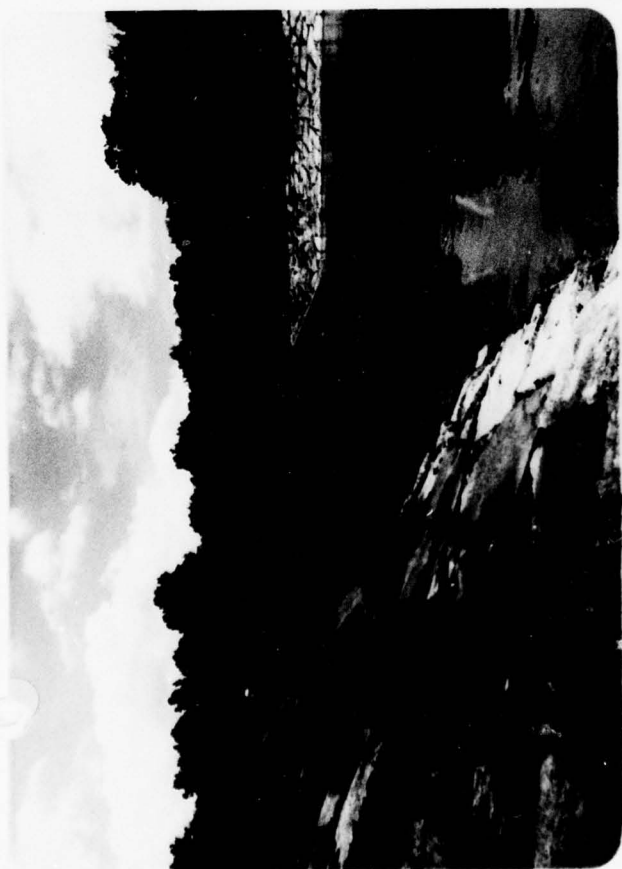
PHOTOGRAPH 9 View of the masonry-lined approach channel to the spillway.
